Memorandum

Re: Lake Davis Detonation Cord Phase I Project Results

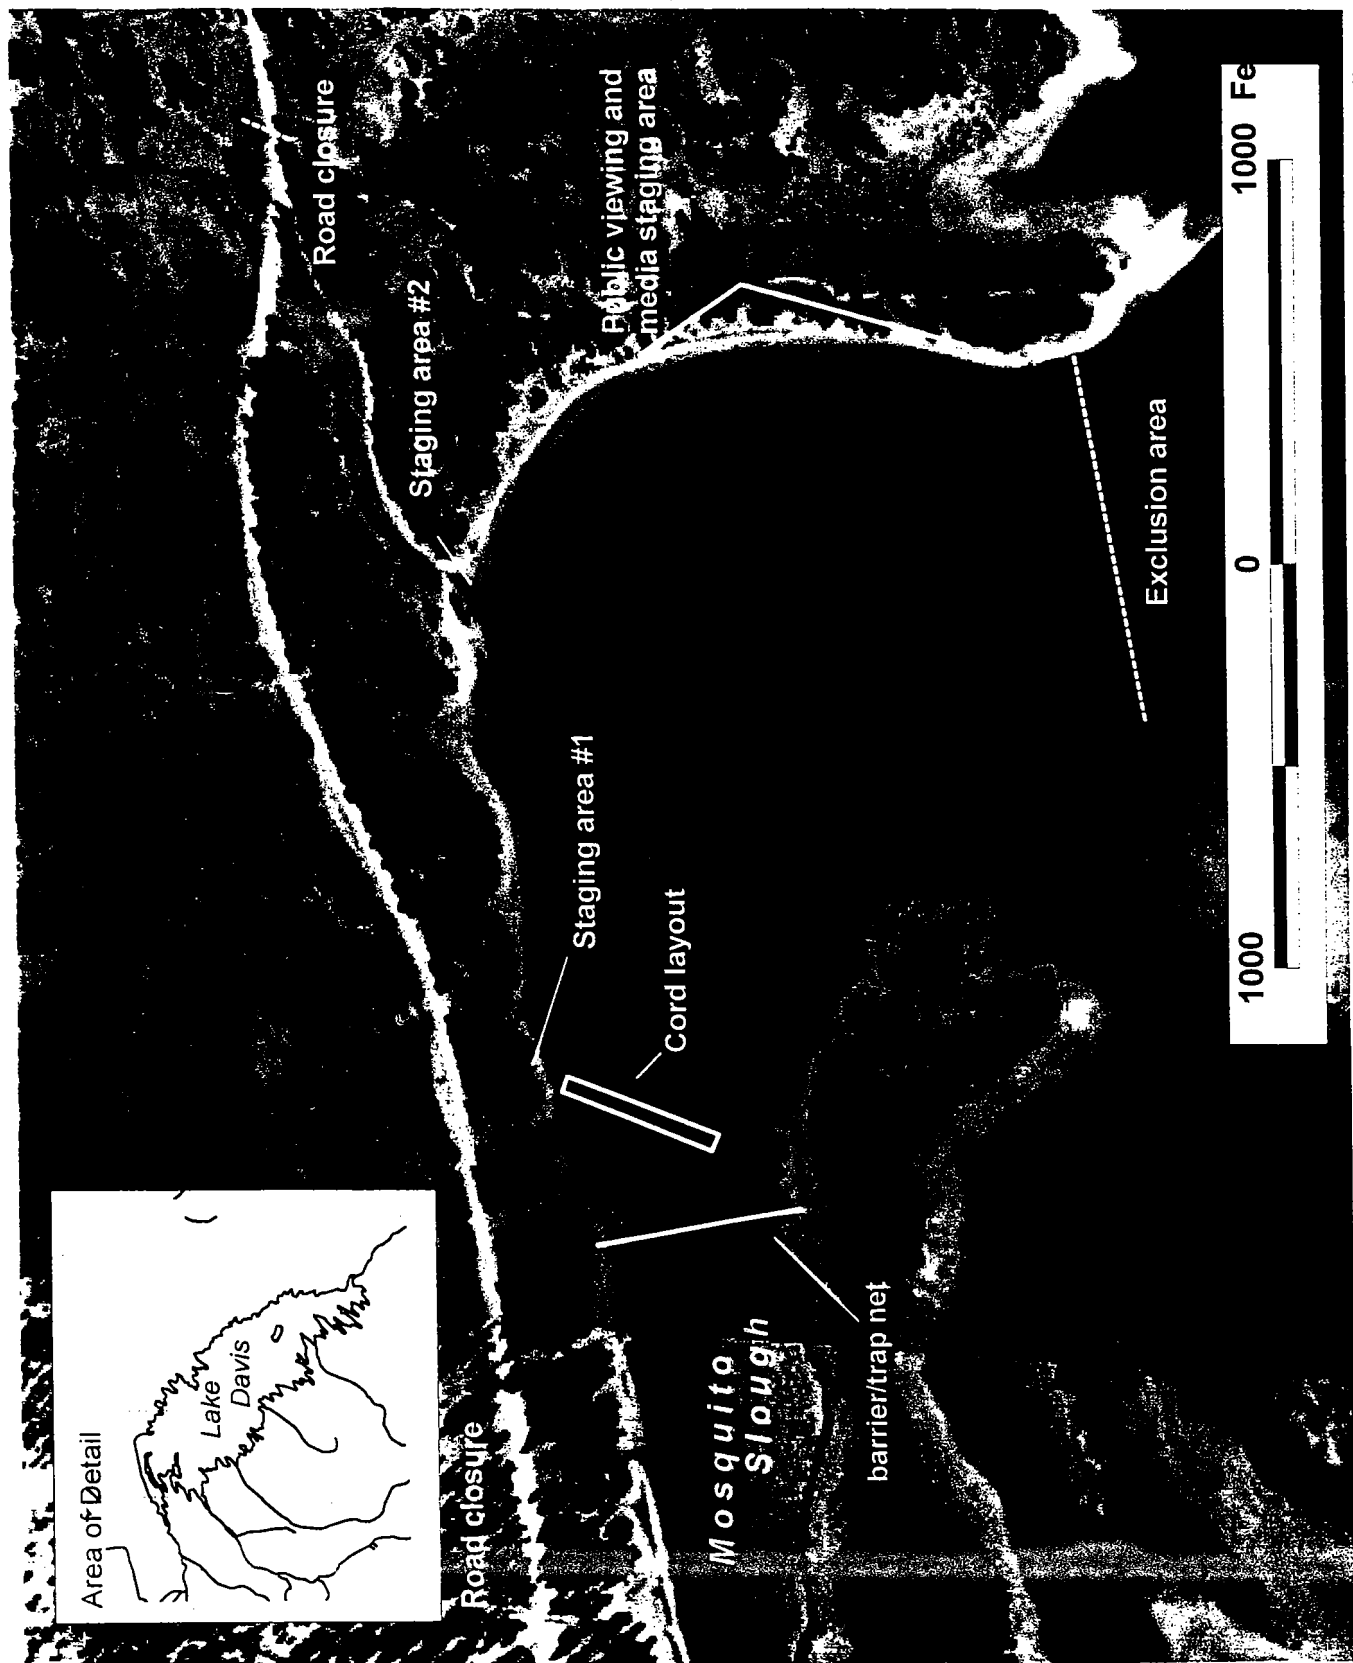
Figure 1. Lake Davis Detonation Cord Project, Phase I Project Area

Phase I of the project was performed on April 24, 2002 at the north end of the reservoir in Mosquito Slough (Figure 1). The purpose of Phase I was to determine the effective kill radius of the cord on northern pike in the Lake Davis environment, to evaluate water quality effects, noise and ground motion, and to provide the public and the media with an opportunity to observe and learn about the technique. Although Phase I was originally designed to target pike near the time of spawning, the Department decided to focus Phase I on data collection and public information rather than targeting large quantities of free-swimming

Steve Martarano, Information Officer, Office of Conservation Education, and Ivan Paulsen, Senior Fisheries Biologist, coordinated public viewing and media relations. A public viewing area was established with cones and flagging at Fairview point, about 2000 feet south of the project site (Figure 1). Informational brochures on the project were handed out, and DFG personnel were on hand to discuss the project with interested people.

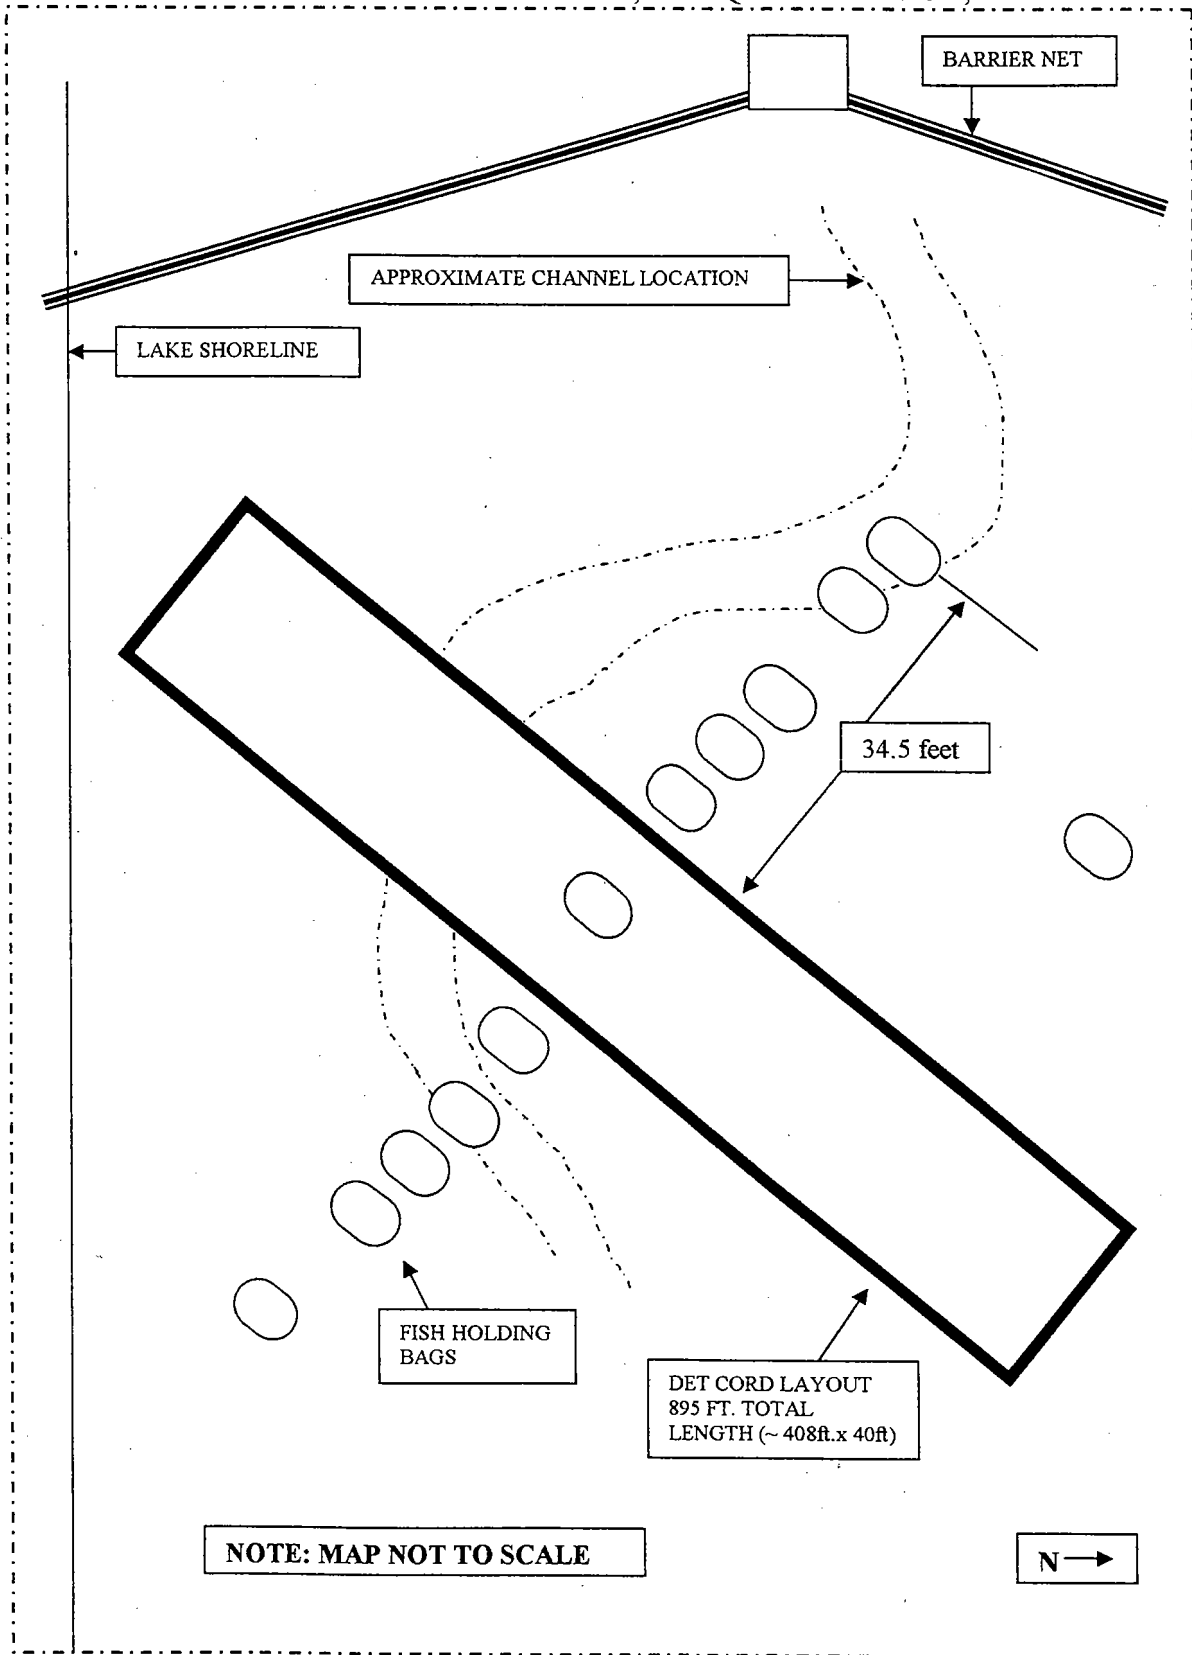
FIGURE 3: DETONATION CORD LAYOUT, MOSQUITO SLOUGH, LAKE DAVIS

Robert Snyder, Fisheries Habitat Supervisor, Central Coast Region, supervised the blasting operation. About 895 feet of 50-grain Primacord detonation cord was laid out by a team of divers in a rectangle about 400 feet by 40 feet across the mouth of Mosquito Slough. The layout was oriented with the two longest segments placed parallel to each other on a bearing of S20W/N20E, and separated by about 40 feet. The cord was anchored on steel posts placed the previous day, and was suspended about midway in the water column. About five feet of the cord emerged above water and was wrapped around the easternmost steel post. Four electric blasting caps, two at each end of the detonation cord, were used to ignite the cord. Water depth in the project area ranged from three to ten feet in an area with a soft and silty substrate. Reservoir level was 5,766.00 feet above mean sea level (eight feet below spill). Surface water temperature was 52 degrees Fahrenheit. The weather was clear and calm.

Twelve 30" long 12" diameter cylindrical mesh holding cars were placed at set distances along a transect perpendicular to the long side of the rectangle of cord (Figure 3). Cars were placed at 5.75-foot intervals in water depths ranging from 3.5 to 10.0 feet. The cars were placed between 2.75 and 3.5 feet from the bottom.

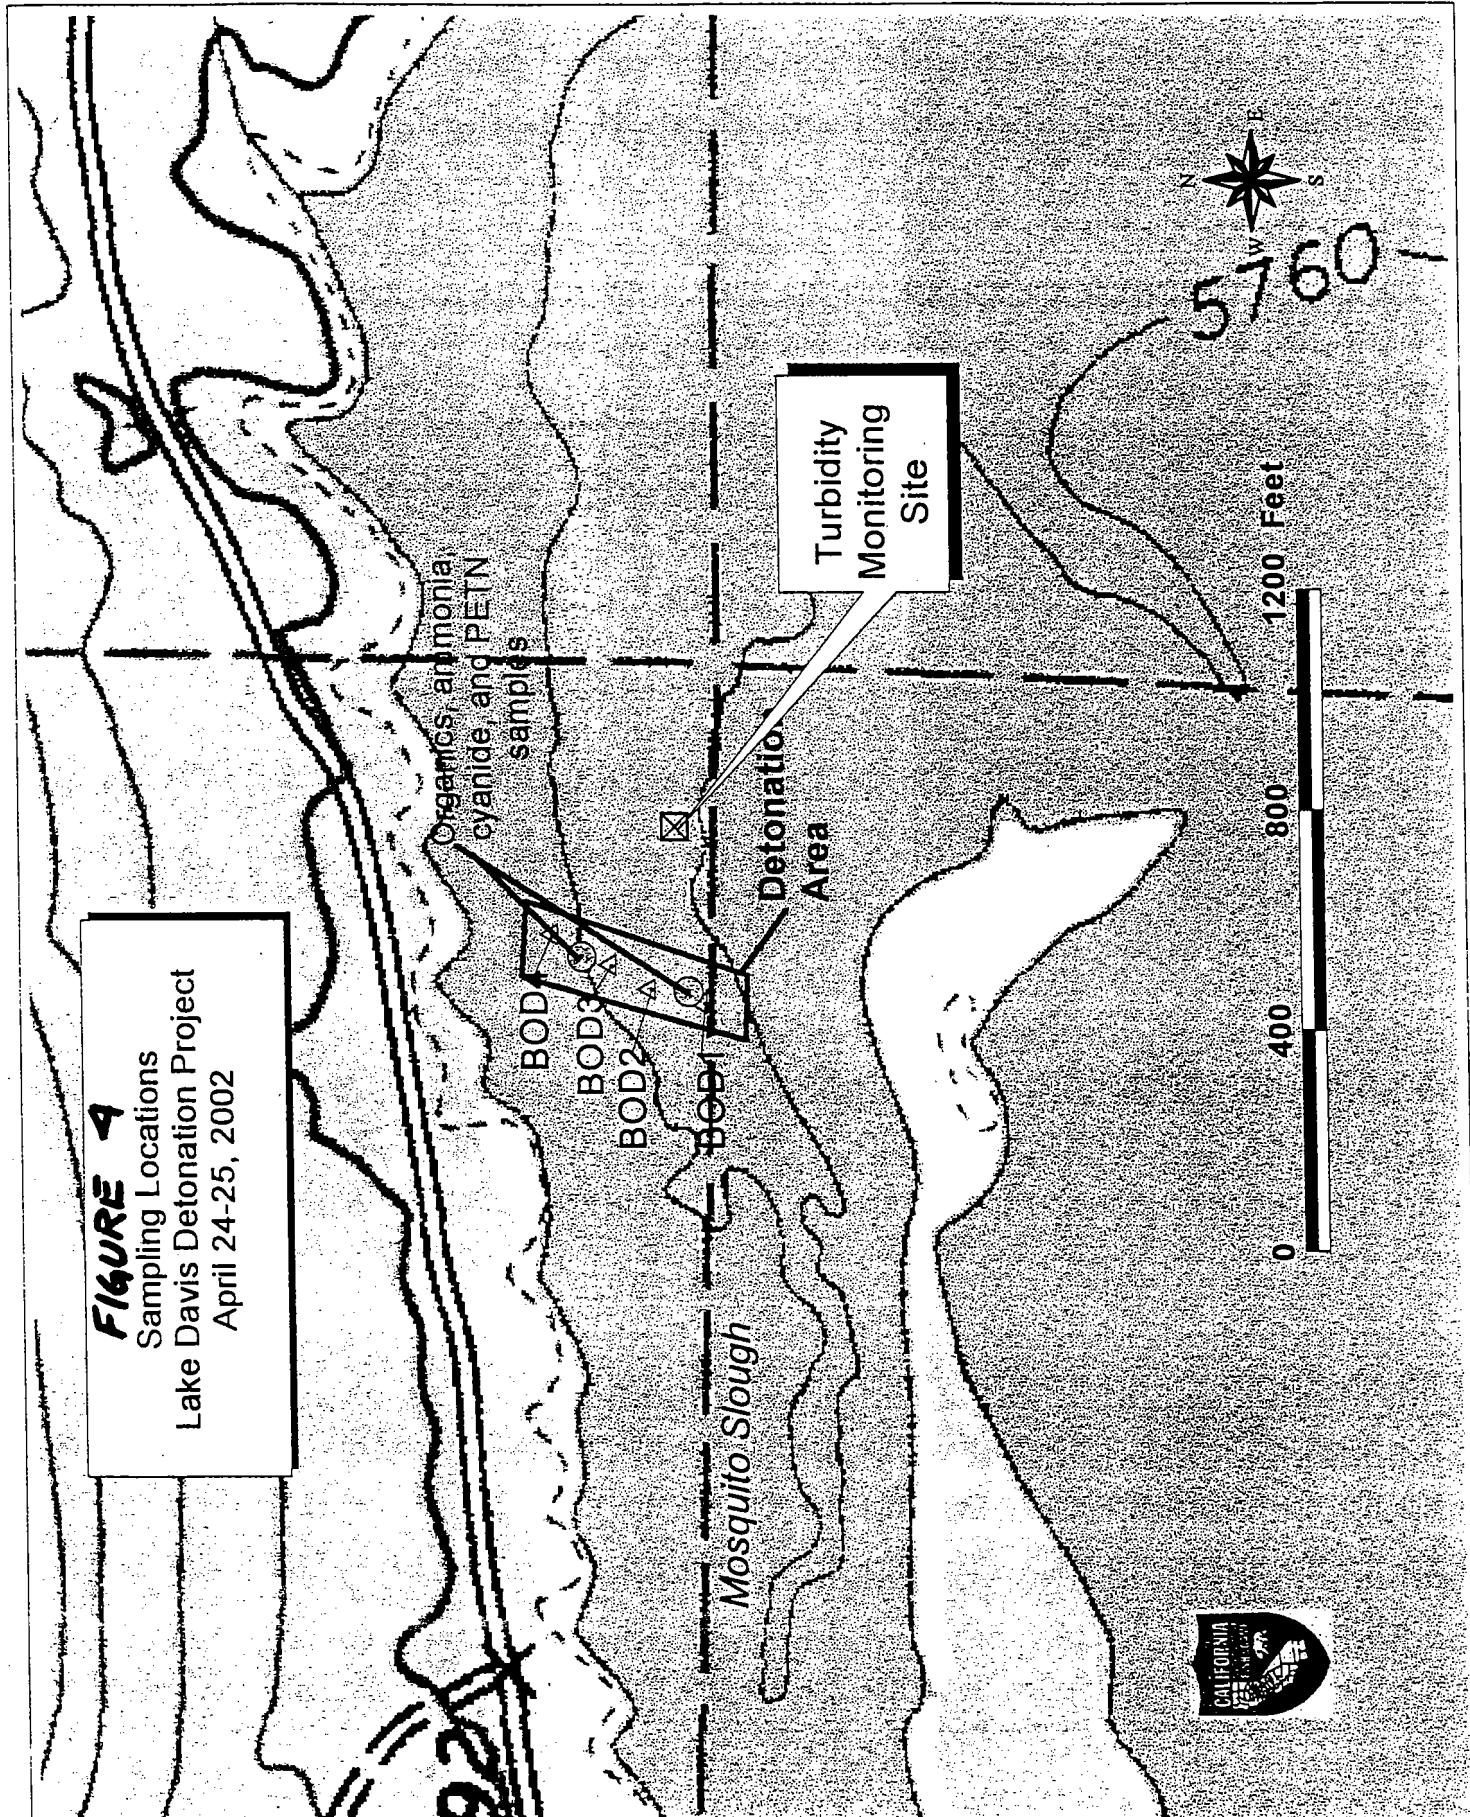
FIGURE 4

Sampling Locations
Lake Davis Detonation Project
April 24-25, 2002

Water was monitored for volatile organics, semi-volatile organics, cyanide, pentaerythritol tetranitrate (PETN), ammonia, and turbidity. Samples were taken at two locations within the area of the detonation cord rectangle about 30 minutes following the test shot (Figure 4). Background samples were collected before the shot. Monitoring for biological oxygen demand and dissolved oxygen was waived after it was determined that there were no fish carcasses remaining in the water.

Turbidity was monitored about 300 feet from the project area in the direction of Grizzly Valley Dam (Figure 4). Turbidity measurements after detonation were within 1 Nephelometric Turbidity Unit (NTU) of background levels, meeting criteria established by the Board. Small mats of floating debris from the polypropylene and cellulose casing were observed and removed using dip nets as prescribed by the contingency plan for solids cleanup.
